Sloan® Flushometer

PARTS LIST

TROUBLESHOOTING GUIDE

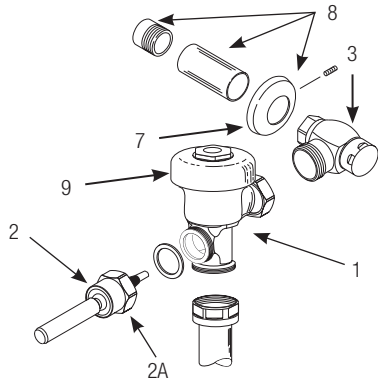
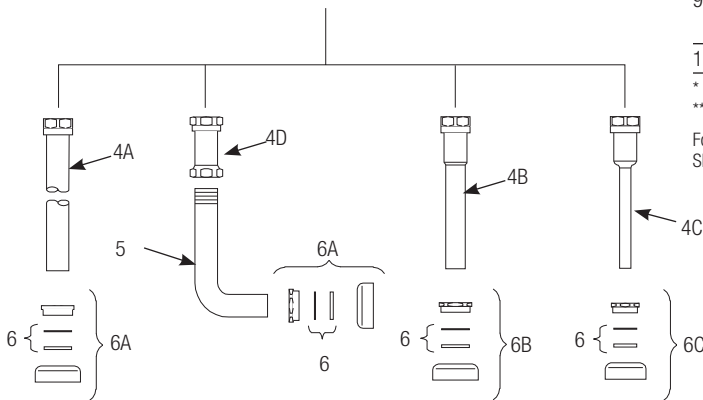
Item No.	Code No.	Part No.	Description
1.	—	A-3-A	Valve Assembly – contact Tech Support for proper assembly
2.	3302002	B-73-A	ADA Compliant Handle Assembly
2A.	0301082PK	A-6	CP Handle Coupling

3.	—	H-710-A	Bak-Chek® Control Stop – 3/4" or 1"
4A.	5323007	V-500-AA	1-1/2" (38 mm) x 9" (229 mm) Vacuum Breaker Assembly ** – 6 per package
4B.	5323006	V-500-AA	1-1/4" (32 mm) x 9" (229 mm) Vacuum Breaker Assembly – 6 per package
4C.	5323005	V-500-AA	3/4" (19 mm) x 9" (229 mm) Vacuum Breaker Assembly – 6 per package
4D.	5323010	V-500-A	Short Vacuum Breaker Assembly (6 per pack)

5.	0396293PK	F-109	1-1/2" (38 mm) Elbow Flush Connection
6.	SEE SLIP JOINT GASKETS AND RINGS TABLE BELOW		
6A.	0306145	F-56-A	1-1/2" (38 mm) Spud Coupling Assembly
6B.	0306142	F-55-A	1-1/4" (32 mm) Spud Coupling Assembly
6C.	0306102	F-54-A	3/4" (19 mm) Spud Coupling Assembly

7.	—	F-7	Supply Flange (Supplied when Valve is not ordered with Sweat Solder Kit)
8.	3308782	H-633-AA	1" (25 mm) Sweat Solder Kit with Cast Set Screw Flange
	3308788	H-636-AA	3/4" (19 mm) Sweat Solder Kit with Cast Set Screw Flange

9.	0378000PK	SV-10	CP Sloo Cover
	0378003PK	SV-10-HE	CP High Efficiency Sloo Cover
10.	3388015	H-1015	Flow Control Kit (not Shown)(HEU Only)

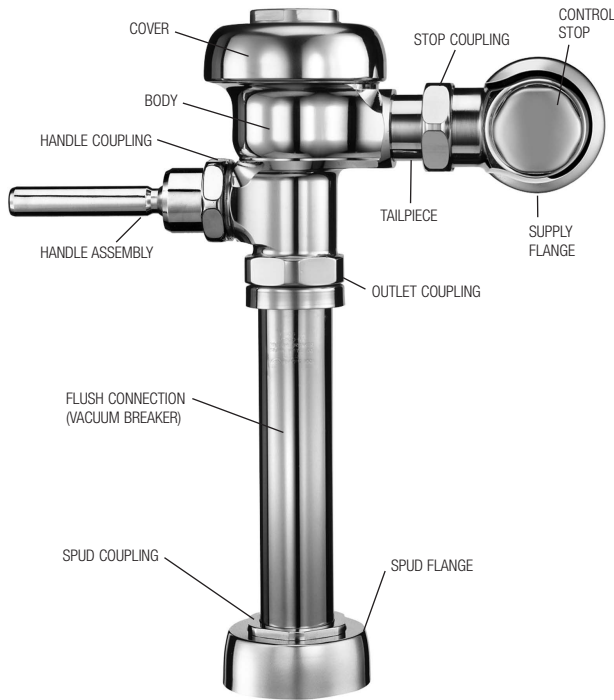
DIAPHRAGM INSIDE PARTS KITS (SEE ILLUSTRATION BELOW)

Refer to Parts List. Includes Relief Valve and Diaphragm Assembly

Item No.	Code No.	Part No.	Application
A.	3378041	SV-41-A	1.6 gpf/6.0 Lpf - Closet
B.	3378038	SV-38-A	3.5 gpf/13.2 Lpf - Closet
C.	3378044	SV-44-A	2.4 gpf/9.0 Lpf - Closet
D.	3378037	SV-37-A	1.5 gpf/5.7 Lpf - Urinal
E.	3378042	SV-42-A	1.0 gpf/3.8 Lpf - Urinal
F.	3378043	SV-43-A	0.5 gpf/1.9 Lpf - Urinal
G.	3378047	SV-47-A	1.28 gpf/4.8 Lpf - Closet

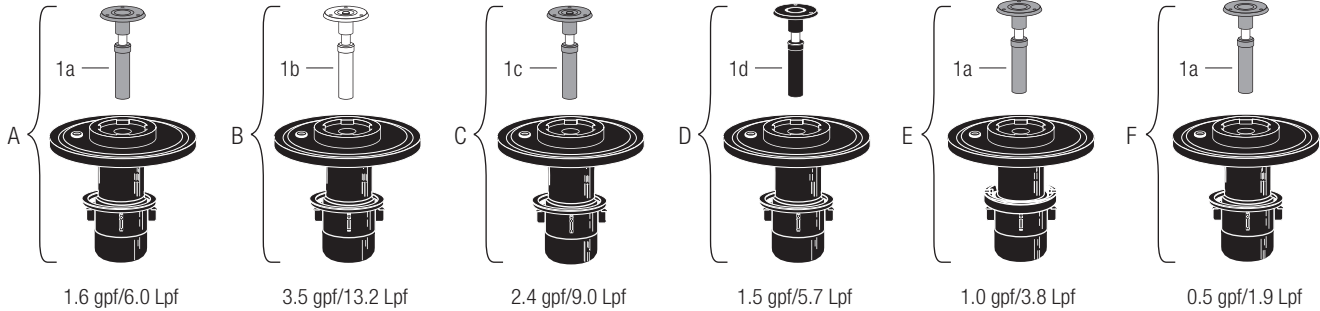
INSIDE COMPONENTS

Item No.	Code No.	Part No.	Description
1a.	5301211	A-19-ALC	Relief Valve, Green (Closet/Urinal-LC) – 12 per package
1b.	5301058	A-19-AC	Relief Valve, White (Closet) – 12 per package
1c.	0301143	A-19-AL	Relief Valve, Blue (9 Liter Closet)
1d.	5301059	A-19-AU	Relief Valve, Black (Urinal) – 12 per package
